# Assessment of RC beams strengthened with near surface mounted CFRP rods by static and dynamic tests

Roberto Capozucca<sup>1</sup>

<sup>1</sup>*Struct. Section of Dept. DACS, Università Politecnica delle Marche, Italy*  
*E-mail: r.capozucca@univpm.it*

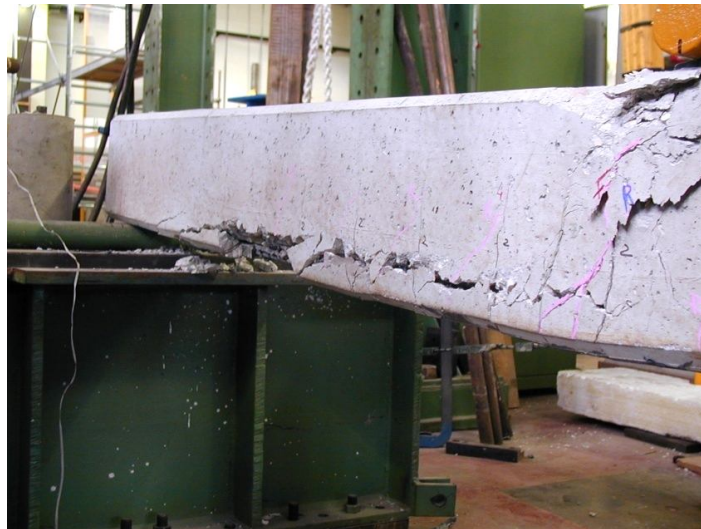
Figure 10: Failure view of strengthened RC beam (B2)

Failure damage of RC beam (B2) is shown in Figure 10. Crash of concrete developed in the compression zone at the extrados of beam where load is applied. At the bottom of beam longitudinal cracking appeared on the cover where CFRP rods are located. Cracking at the intrados of beam did not produce delamination of CFRP bars into grooves. Finally, in the following Table 2 experimental and theoretical results for B3 beam model with and without strengthening due to NSM CFRP bars are shown.

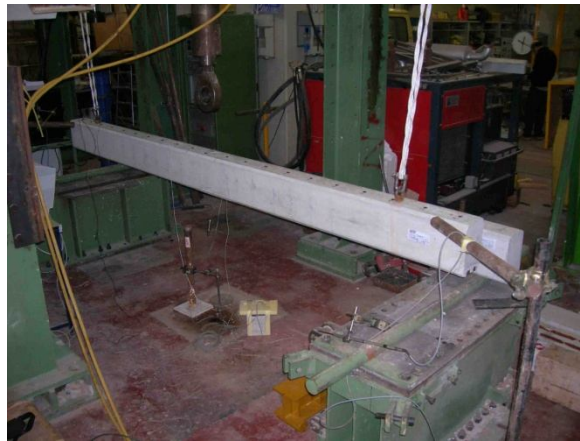
Figure 11: Dynamic tests of vibration on RC beam (B1) with free-free ends.

The B1, B2 and B3 beams have been analysed by dynamic tests to measure experimental dynamic parameters before and after damage and, successively, with the strengthening by CFRP rods. The dynamic tests were used to monitor the behaviour of beams [15,16]. At every damage degree D1...D4, removed load, dynamic vibration tests have been carried out on beams without constraints in free-free end condition (Fig. 11). To measure dynamic parameters the following instruments were utilized:

- piezoelectric accelerometer ( model 4508 Brüel & Kjær) on steel plates glued to the beam model with sensibility 100 mV/g and maximum value of measure 700 m/s<sup>2</sup>( 70 g );
- impact hammer with load cell (model 8202 Brüel & Kjær) and sensibility -1 mV/N;
- pulse system code to record dynamic values.

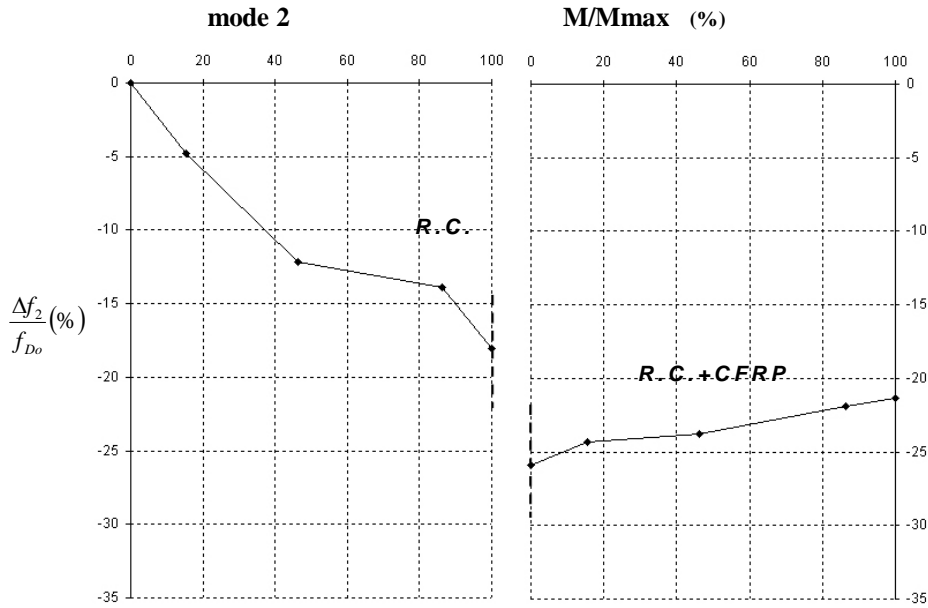
Figure 13: Variation of frequency vs. moment ratio for 2<sup>nd</sup> mode of vibration.

Finally, the Figures 12, 13 and 14 frequency variation ratio,  $\Delta f_i/f_{D_0}$ , vs moment ratio,  $M/M_{max}$ , for B1 beam without and with strengthening are shown. It can be note a decrease of frequency in the case of RC beam due to increase of damage degree, from D<sub>0</sub> to D<sub>4</sub> while in the case of beam with strengthening, frequency values are almost constant or with a light increase.
